High Rise Buildings  
Glass rectification & Protection  
Glass contaminations

Project: Pinnacle Apartments, Dind Street, Milsions Point  
Owner: Sydney, Australia  
Company: Multiplex

Contractor: Karabiner Access Pty Ltd , Alexandria ,Australia  
Year: 2007/2008

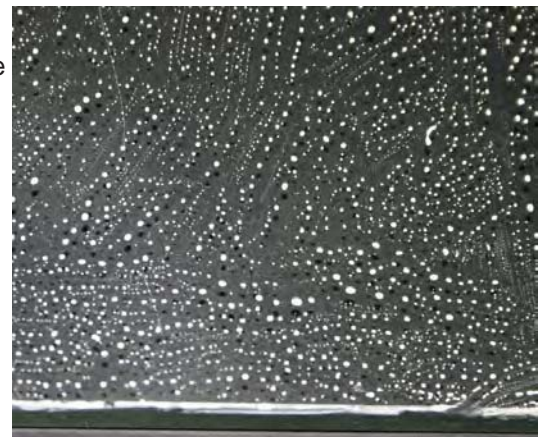
The Pinnacle Apartments in North Sydney are a prestigious residential development. While its proximity to the harbour and CBD offer amazing views, it suffers from intense exposure to the elements and big city pollution problems. Over time these conditions have caused such a severe build up of contaminants on the glass, views through the windows have been largely obscured. Additional leaching from the rendered facade elements which collected the pollution and saltspray created contaminations on the glass which is extremely stubborn and hard to remove.

Typical glass condition at the Pinnacle

**Rectification-** Over a period of nearly 3 years numerous different methods have been used and some attempts have damaged the glass leaving deep scratches. Not deterred, KA and Nanovations have pulled out all stops to find an efficient cleaning method. After seeking further assistance from their scientists partner and working with the KA crew and a compound removal process was developed that did not damage the glass.

**Protection -** Several glass protection coatings were applied on sample widows after the cleaning to test the durability and protective properties over a period of time. The best performing glass treatment was a product based on a new technology and supplied by Nanovations Pty Ltd.

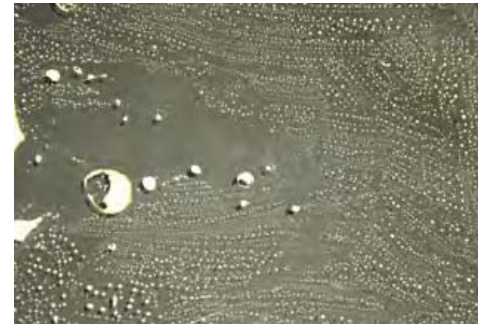
Test area with mineral contamination

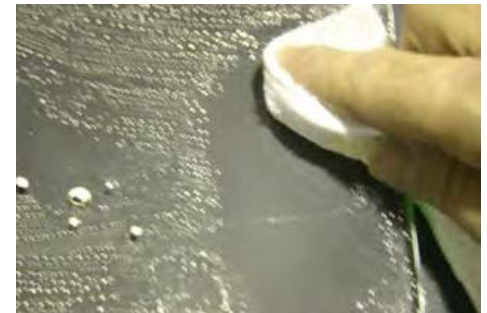
Calcium shows weak bond and can be removed with a micro fiber cloth.

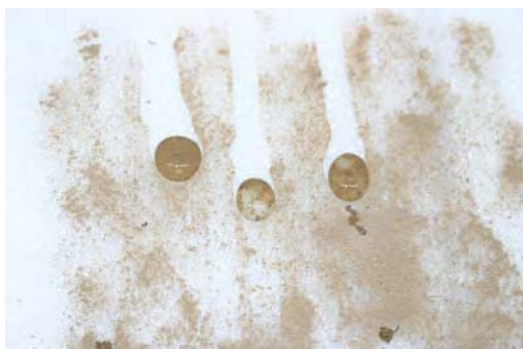
Water droplets pick up dust and dirt from a treated test panel. (self cleaning effect)

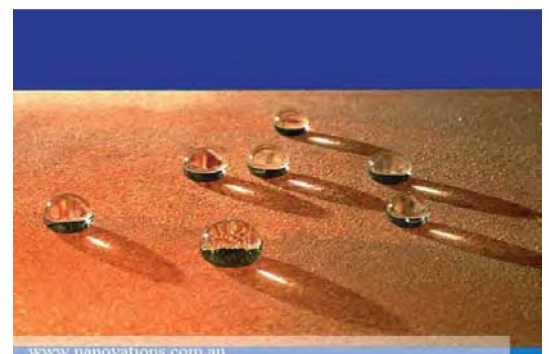
Hydrophobic effect on test panel panel.
